ETAS ES820.1

V7.5 Service Pack 4

Release Notes

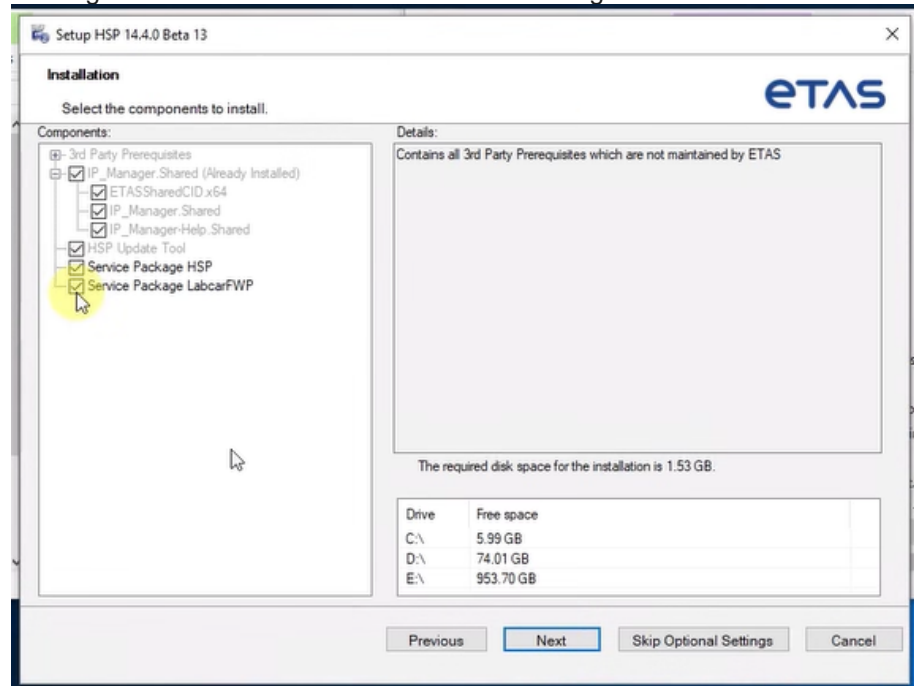
HSP V14.3.0 FW package not installed due to insufficient storage.

Due to insufficient disk space on drive C, HSP must be installed on the D drive of the ES820.

With HSP V14.4.0 installation, the data directory can be changed to the D drive of the ES820 to overcome the lag of insufficient disk space on the C drive.

To ensure that the installation of HSP V14.4.0 or later succeeds, at least 6GB free disk space on the target drive are needed. Also the option Service Package LabcarFWP should be deselected during the installation.

To make the data directory changeable, uninstall an existing HSP completely with all the firmware packages. This will remove the registry key "Computer\HKEY_LOCAL_MACHINE\SOFTWARE\WOW6432Node\ETAS\HSP\ProductData". Additionally look that are no leftovers in the default directory "C:\ETASData\HSP". In very rare cases the uninstallation cannot delete the complete directory. If the Registry key "Computer\HKEY_LOCAL_MACHINE\SOFTWARE\WOW6432Node\ETAS\HSP\ProductData" does not exist and the directory "C:\ETASData\HSP" does not exist, then the data directory can be changed during installation. Then do a fresh install and change the data directory.
